# **Retention of Pre-construction Primer in Tank Coating Systems**

**NSRP Project 3-96-3**

**November 2002**

**PREPARED BY:  
ASSOCIATED COATINGS CONSULTANTS, INC.  
And  
NATIONAL STEEL AND SHIPBUILDING  
IN COOPERATION WITH  
FRIEDE GOLDMAN HALTER  
GULFPORT, MS**

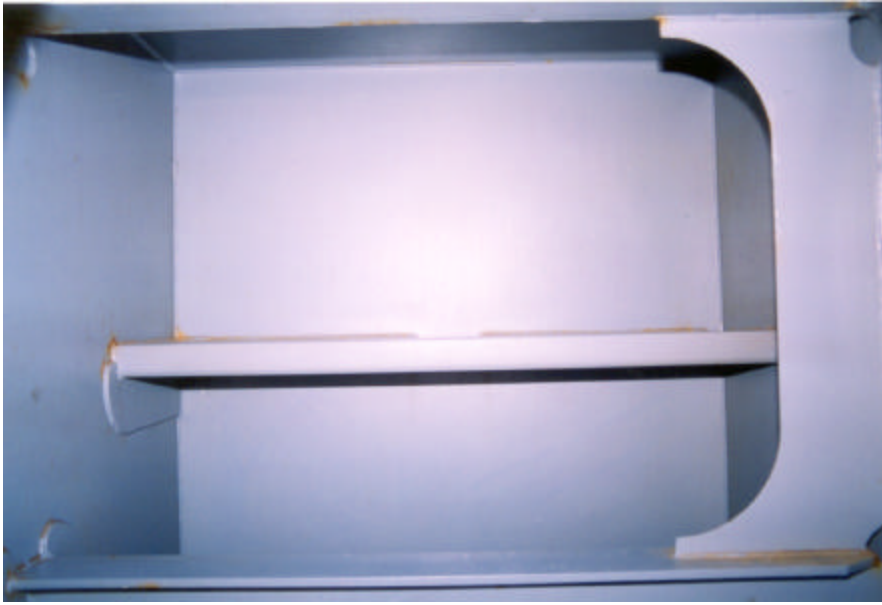
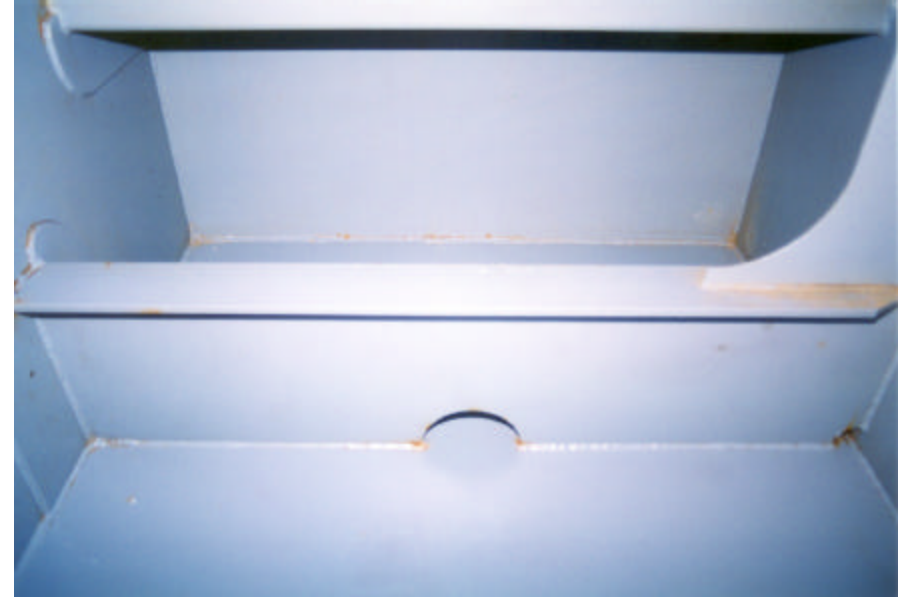
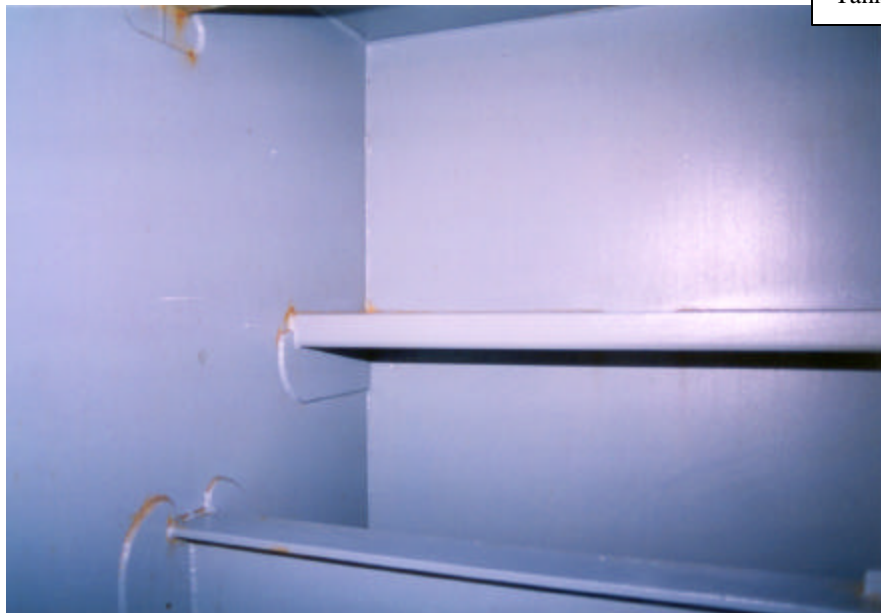
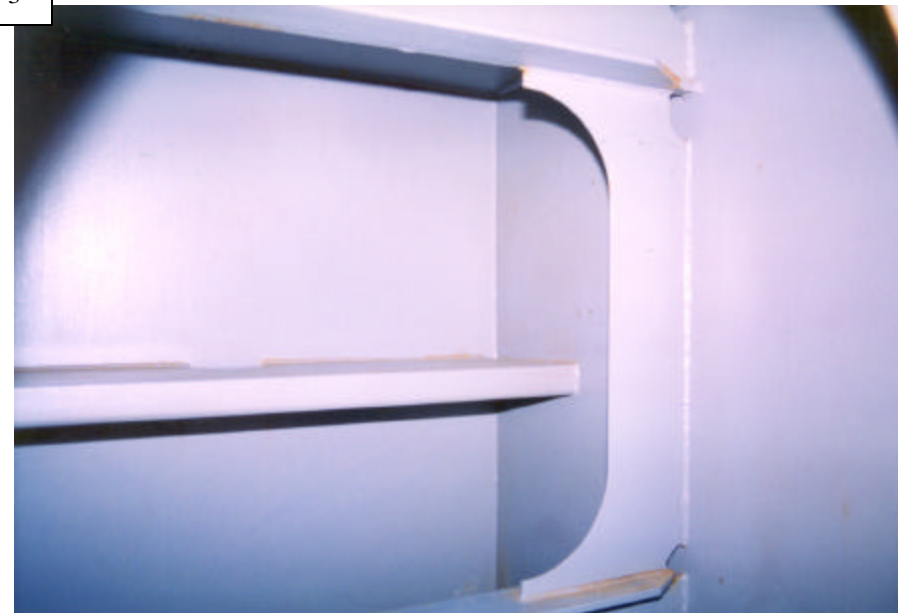
Tank D-3

<b>Tank D-3- Control Two - Primer completely removed; Topcoat- Mil-P-24441, Type IV</b>						
<b>Surface Preparation Initial: SSPC SP-10</b>			<b>Secondary: SSPC SP-10</b>			<b>Total Dry Film Thickness: 10-17 mils</b>
<b>Surface Graded</b>	<b>ASTM D-610 Rust</b>	<b>ASTM F1130 Inspection</b>	<b>ASTM D-714 Blistering</b>	<b>CLER Condition</b>	<b>Edge Failure</b>	<b>Remarks</b>
Top - Flat	8G	1B	None	1	None	Failure at wet film thickness measurement.
Top - Stiffener	8G	1B	None	1	None	Insufficient film thickness.
Top - Fill Port	4G	8S	None	1	None	Failure on threads only.
Back - Flats	9S (T)/5S (B)	1B	None	1	None	
Back - Stiffener (HP)	9S	1L	None	1	None	
Bottom - Flats	9S	1B	4MD	1	None	Blister at front only.
Bottom - Stiffener	4G	8M	None	1	None	4-inch by 12-inch failure on backside.
Bottom - Drain	10	1B	None	1	None	
Right Side - Flat	10	0	None	1	None	
Left Side - Flat	9S	1B	None	1	None	Limited to weld area.

Side Structure	10(F)/3G(B)	8S	None	2	None	Failure limited to backside
Front Flat	5G	8H	None	1	None	Edge of hatch opening
Hatch	5G	2M	None	1	None	Limited to left edge only.
Additional Remarks:
